Manhole Inspection Summary

Manhole # S19CC1016MH

Insp Date: **3/12/07 1:18 PM**

Location Address: **3665 KEYSTONE AVE**

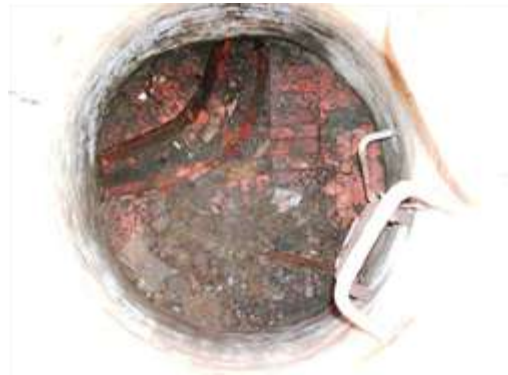
Top View

Corroded steps. Evidence of surcharge - Bench debris. Channel debris.

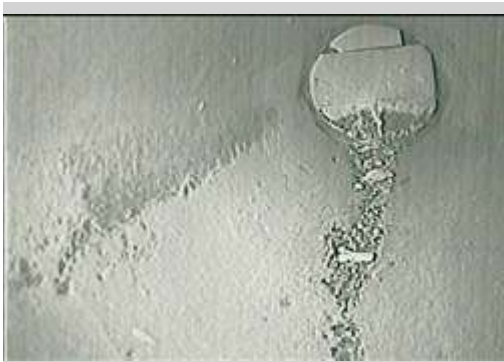
Inside of the I9

Abandoned.

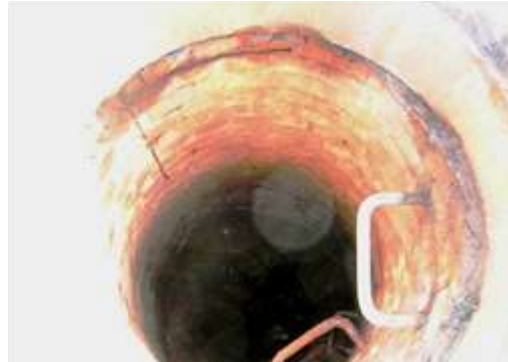
Defect

Adjustment and Corbel deterioration and infiltration. Barrel infiltration - other side.

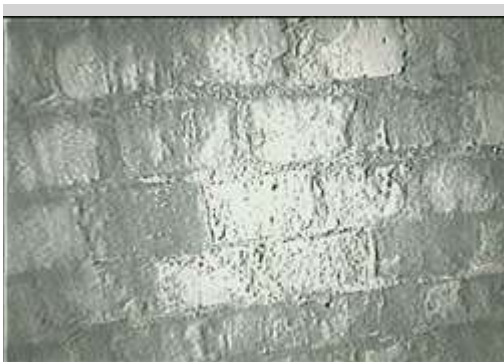
Defect

Barrel infiltration.

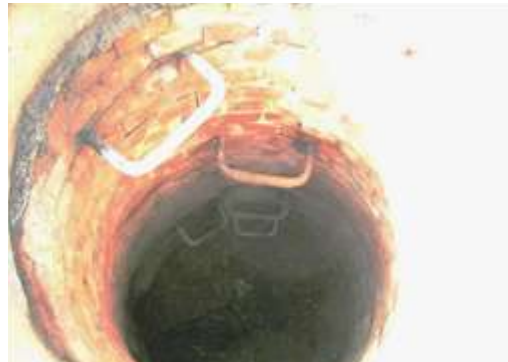
Defect

Adjustment and Corbel deterioration and infiltration. Barrel infiltration.

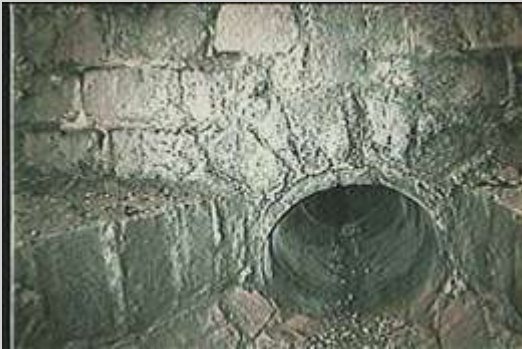
8 in. Circular Gravity Sewer Pipe Out @ 12 O'Clock

Barrel deterioration and infiltration.

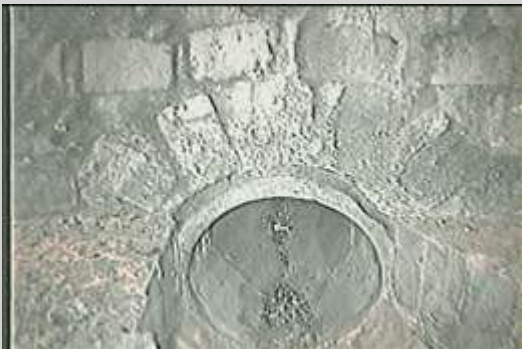
8 in. Circular Gravity Sewer Pipe In @ 9 O'Clock

Deposits: ☐ None ☐ Mud ☐ Sludge ☒ **Debris** ☐ Grease

Infiltration: **Evidence** Pipe Seal Cond: **Unknown**

Connects To: **Stub connection / abandoned**
